umweltbundesamt^U
ENVIRONMENT AGENCY AUSTRIA

NPP Paks II

**Paleoseismological assessment of the Siting Report
and the Site License with respect to fault capability**

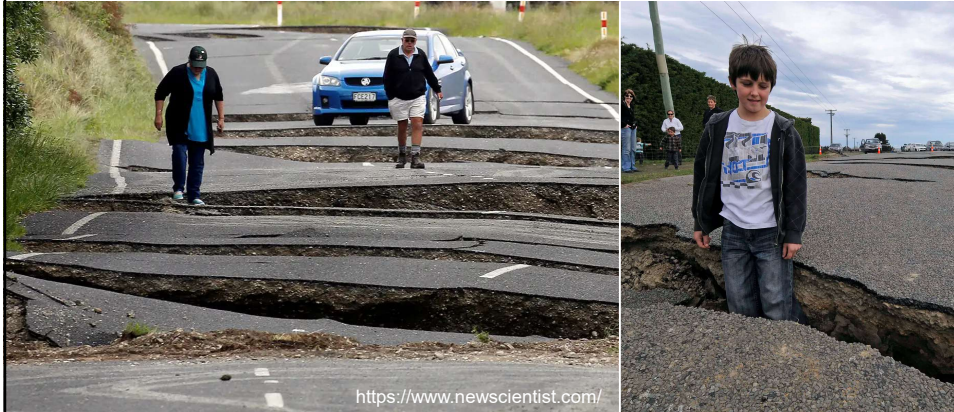
Surface rupture of the 2010 Darfield Earthquake (New Zealand)

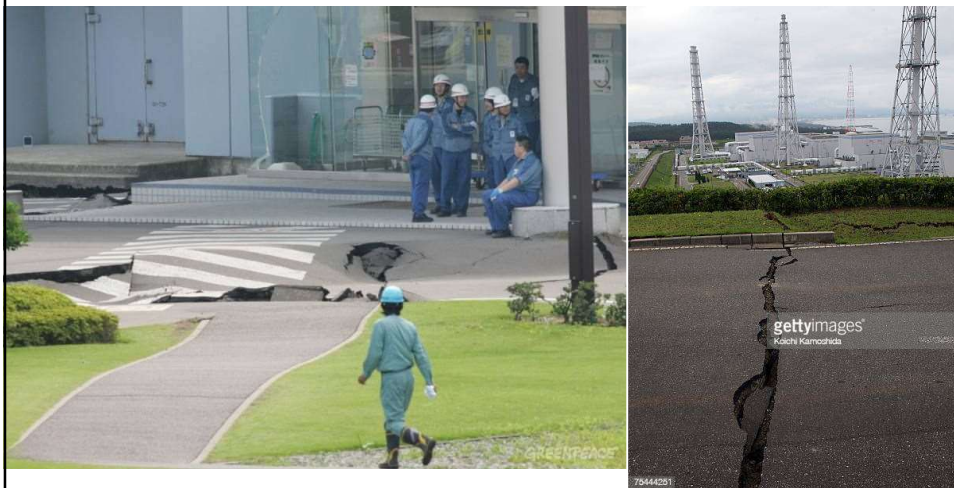
2007 Niigata earthquake (Japan)

Kashiwazaki Kariwa NPP: fractures on the surface of the site and damaged access road.

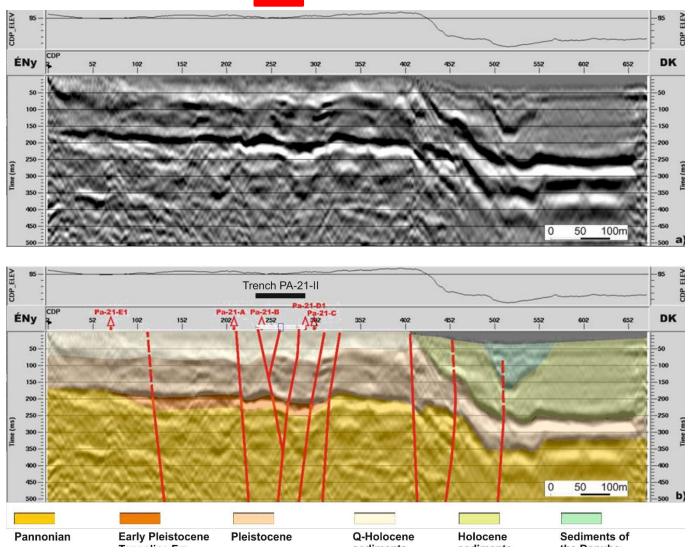
Figure: Geological Site Report, Acs et al., 2016, Fig. 420

Seismic profile Pa-21-S across part of the DHFZ (700 m SE of the existing NPP Paks)

The profile shows 10 individual faults (indicated by the red lines) that offset even the youngest sediments of the Danube. These faults are shown to reach up to the surface.

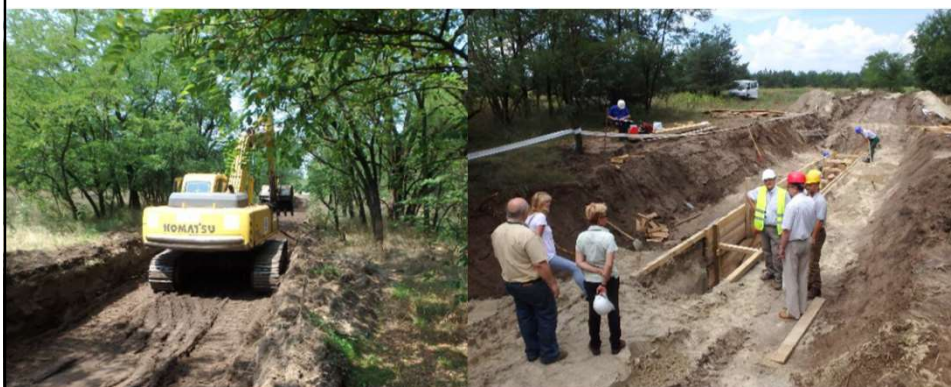
Figure: Geological Site Report, Hálász et al., 2016, Fig. 11 and 12

Paleoseismological assessment of a branch fault of the DHFZ in a 82 m long / 2.8 m deep excavation:

Trench Pa21-II ca. 700 m SE of the existing NPP

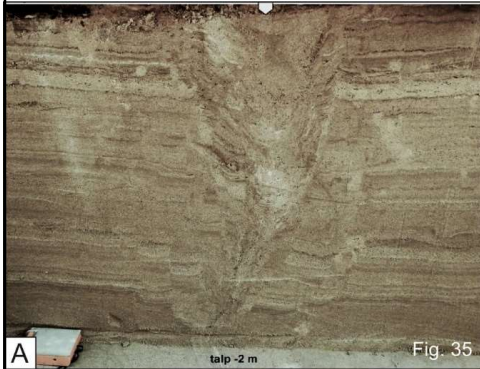
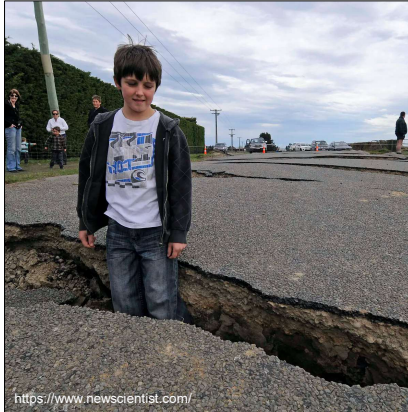
Figure: Geological Site Report, Hálasz et al., 2016, Fig. 27 and 35

Paleoseismological assessment of a branch fault of the DHFZ in a 82 m long / 2.8 m deep excavation:

Trench Pa21-II ca. 700 m SE of the existing NPP

(A) depicts a surface breaking fault that disrupts and offsets about 19.000 to 20.000 years old flood sediments of the Danube.
