The EPR – the future of nuclear expansion or rather a failed technology?

Old and new design problems: Oda Becker

19 Sep 2022

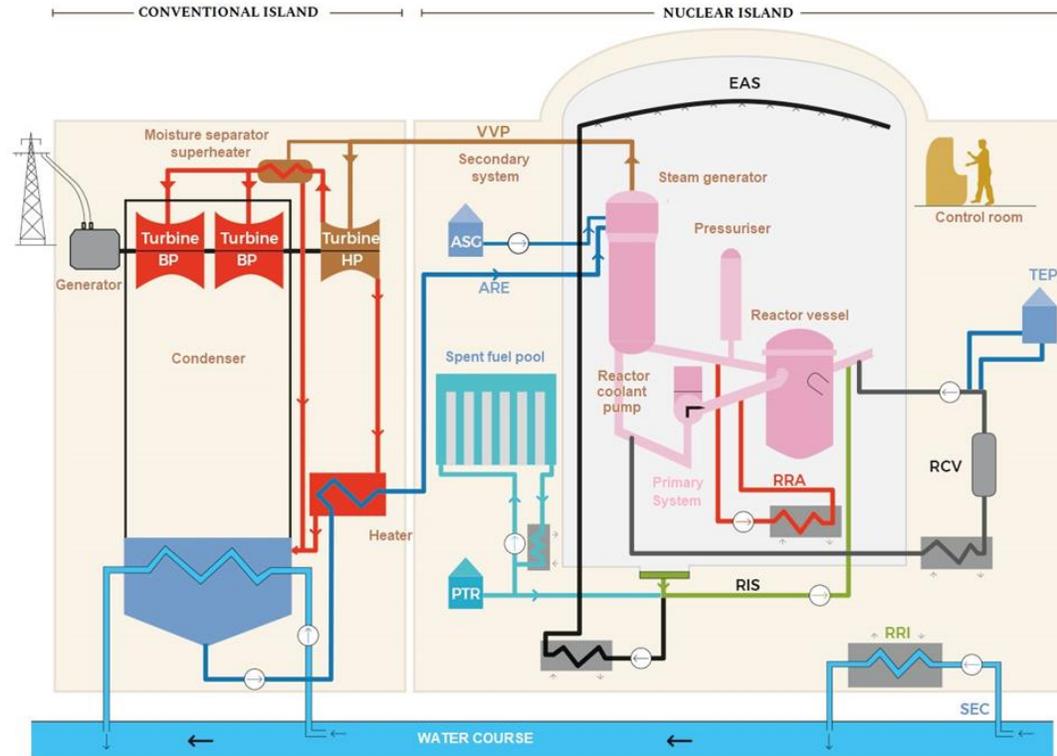
Corrosion Problems

ARE: Feedwater flow control system
 ASG: Auxiliary feedwater system for Steam Generator
 EAS: Containment spray system
 PTR: Reactor cavity and spent fuel pit cooling and treatment system
 RCV: Chemical and volume control system
 RIS: Safety injection system
 ◻: Exchanger

RRA: Residual heat removal system
 RRI: Component cooling system
 SEC: Essential service water system
 TEP: Boron recycle system
 Turbine BP or HP: LP (low pressure) or HP (high pressure) turbine
 VVP: Main steam system
 ⊕: Pump

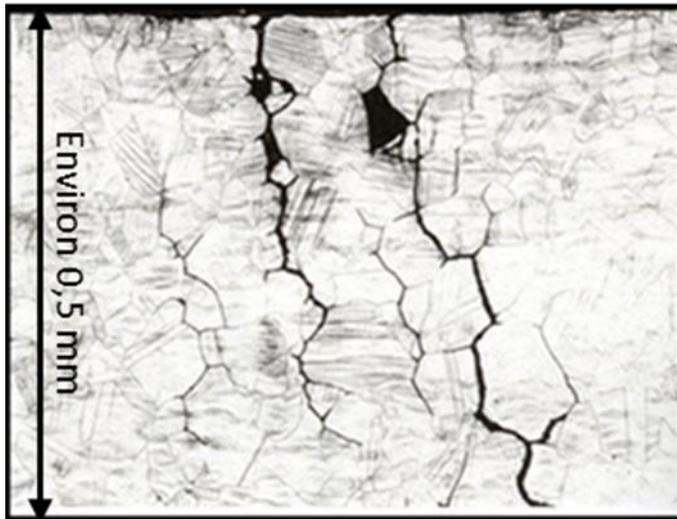
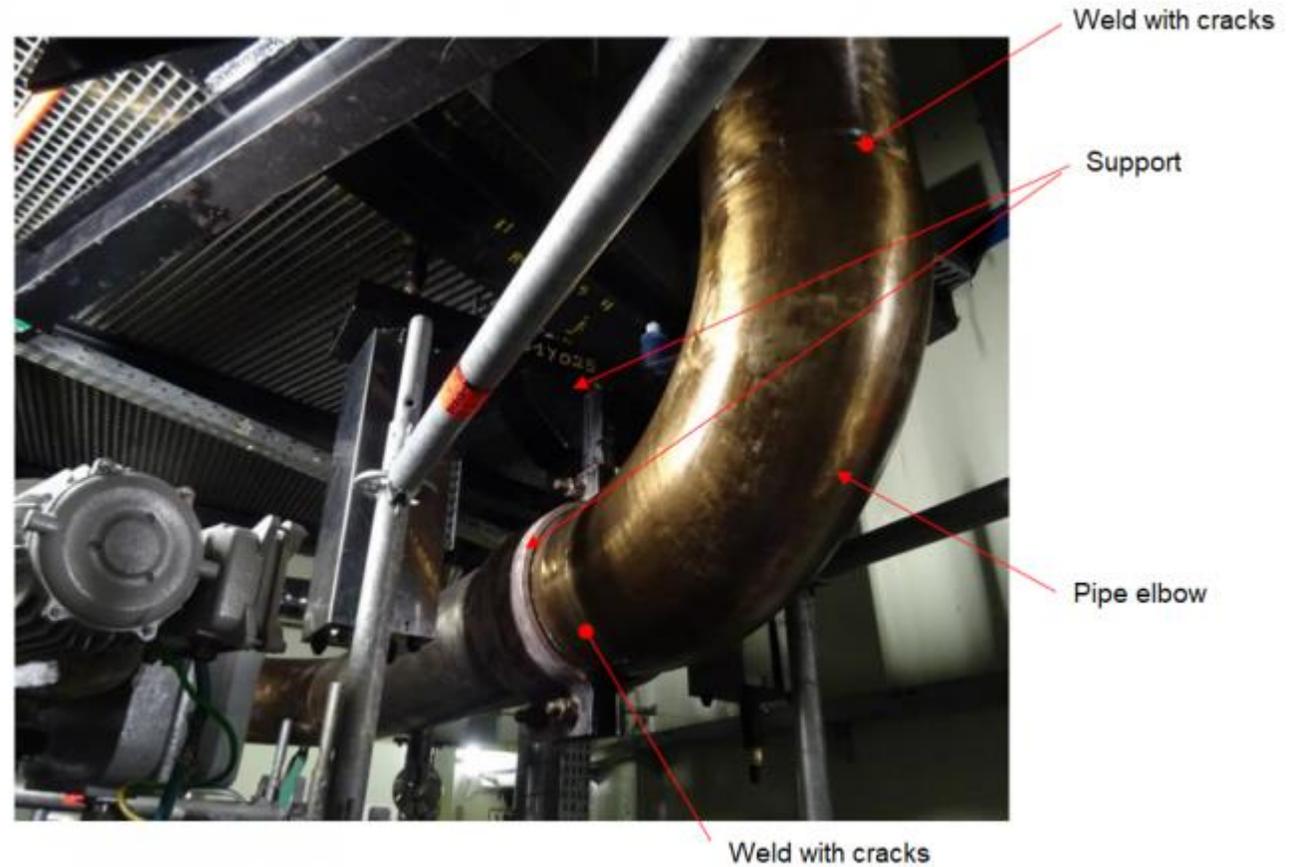
Corrosion issue

Ultrasonic examinations revealed the presence of faults near the welds of some pipe elbows.

- On 21 October 2021, following ultrasonic inspections performed during the ten-yearly outage inspection of the Civaux NPP, EDF had detected “indications” on welds on the elbows of the pipes connecting the safety injection system to the reactor’s main primary system. (emergency core cooling system)
- In order to identify the origin of these indications, the parts of the pipes concerned were cut for metallurgical analysis in the laboratory.
- **This type of crack was not expected on these stainless-steel lines.**
